**VACUUM THERMAL-MECHANICAL
FATIGUE TESTING OF TWO IRON BASE
HIGH TEMPERATURE ALLOYS**

TOPICAL REPORT NO. 3

TRW MATERIALS TECHNOLOGY LABORATORIES

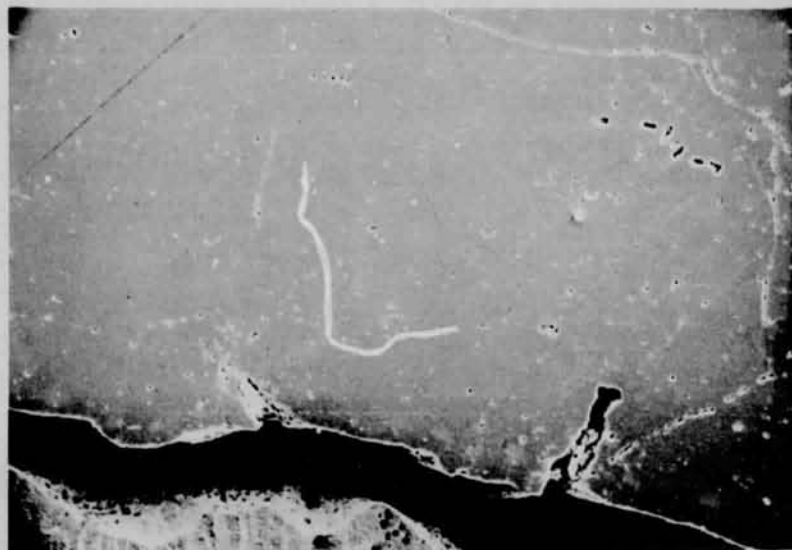
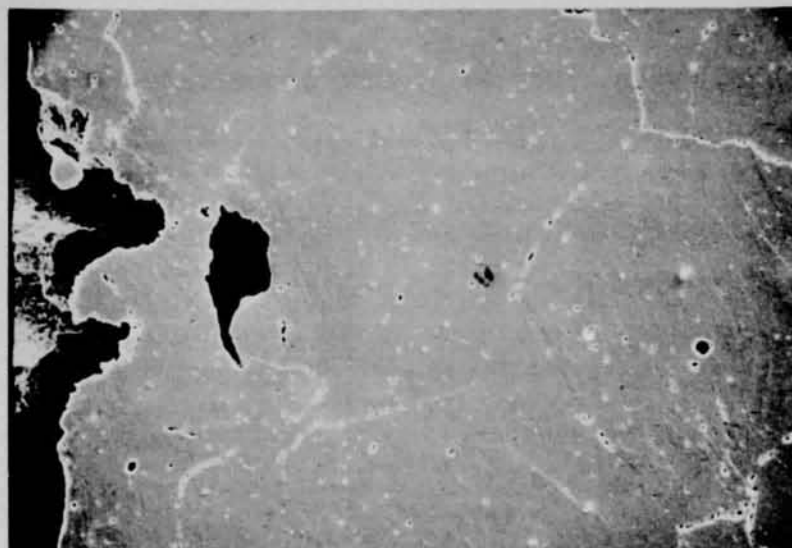
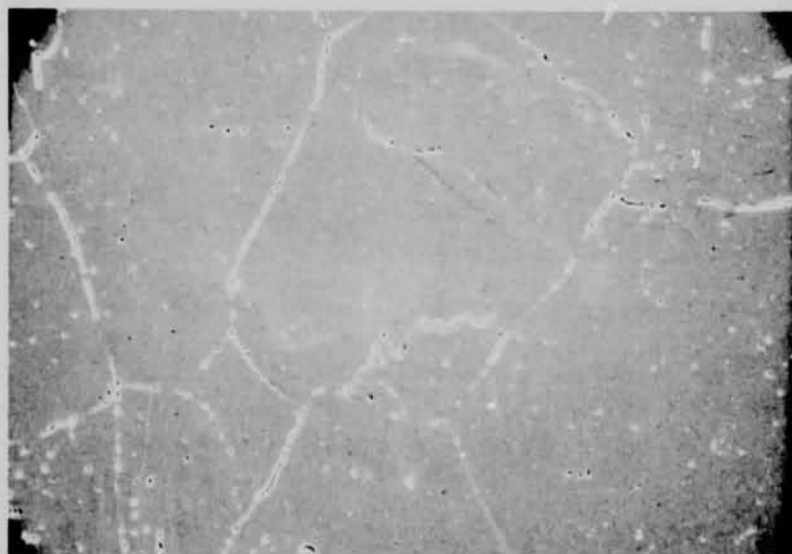
(a) Interior of specimen approximately .3mm below fracture surface

(b) Secondary grain boundary crack immediately below fracture surface.

(c) Transgranular and intergranular secondary cracks approximately 1.5mm below fracture surface.

Figure 8. 304 stainless steel fatigue tested isothermally at 1200°F (922°K), .65 Hz, longitudinal inelastic strain range 0.0108, cycles to failure 4483. Tensile axis parallel to long edge of photomicrographs. Magnification 500X

Microstructural damage observed in the fatigue tested specimens varied with both cycle type and test material, as shown in Figures 8 through 15. Neither alloy showed evidence of significant internal damage with isothermal high frequency cycling (Figures 8a and 9a). Both alloys exhibited mixed mode cracking under these test conditions, as shown in Figures 8 and 9b and c. Some tendency for cracking at twin boundaries was also observed in the 304 stainless steel (Figure 8c). Some of the secondary cracks observed in A-286 appeared to be associated with carbide inclusions (Figure 9d). While this association was assumed to have some influence on cyclic life of the A-286 alloy, it was not thought to influence the life differences caused by different types of cycles, since the carbide associated cracking was observed in A-286 for all cycle types.

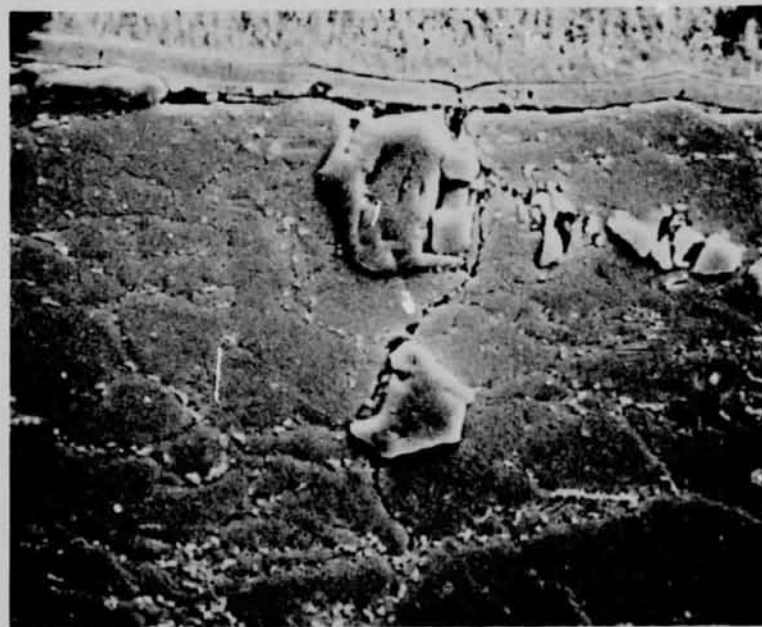
(a) Structure in interior of specimen approximately .3mm below fracture surface.

(b) Secondary crack approximately 1.8mm below fracture surface.

Figure 11. A-286 alloy fatigue tested isothermally at 1100°F (866°K), .0065 Hz, longitudinal inelastic strain range .0072, cycles to failure 2319. Tensile axis parallel to long dimension of photomicrograph. Magnification 2000X.

Secondary cracking in the low frequency isothermal specimens was exclusively intergranular in both materials (Figures 10b and 11b). The A-286 alloy exhibited little internal damage except for the occasional appearance of carbide associated cracks (Figure 11). The 304 stainless steel alloy exhibited localized damage at grain and twin boundaries. This damage was characterized by boundary serration and localized intergranular cracking (Figure 10a).

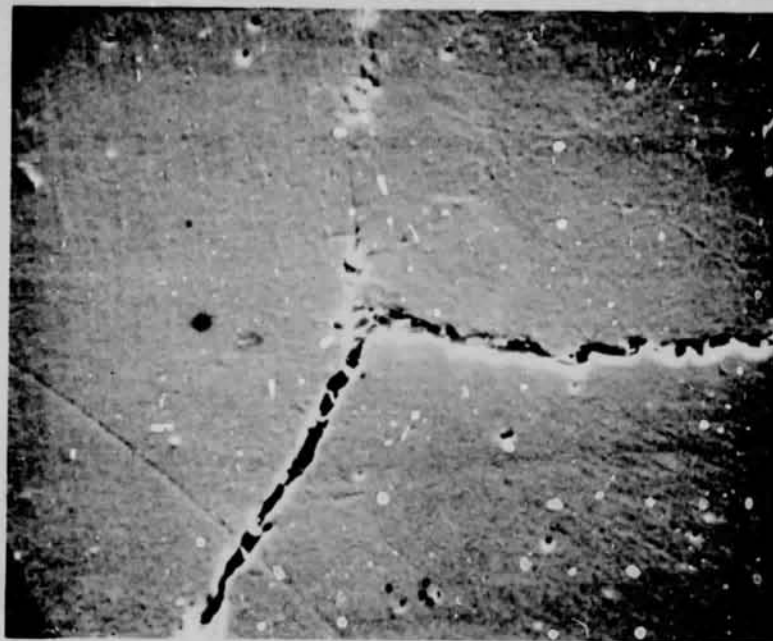
(a) Grain boundary decohesion in interior of specimen approximately 1.8mm below fracture surface.
2000X

(b) Intergranular secondary cracking approximately 2.6mm below fracture surface.
1000X

Figure 12. 304 stainless steel fatigue tested with in-phase thermal cycling (tension isothermal at 1200°F (922°K); compression isothermal at 600°F (589°K), .0065 Hz, longitudinal inelastic strain range .0103, cycles to failure 455. Tensile axis parallel to long edge of photomicrograph.

In-phase thermal cycling caused severe internal grain boundary cavitation in both alloys (Figures 12 and 13). This grain boundary decohesion was assumed to be the cause of premature fatigue failure. Boundary cavitation was attributed to unreversed tensile grain boundary sliding generated by inelastic tensile strain introduced at a high temperature where grain boundary sliding occurs, and reversed by inelastic compressive strain at a low temperature where grain boundary sliding does not occur. Numerous carbide associated cracks were observed in the in-phase cycled A-286 alloy (Figure 13d).
